**BUILDING INSPECTION REPORT
OF
DONALD THOMAS CENTRE, CAMBORNE**

**Scott and Company
3 Lemon Villas
Truro TR1 2NX**

**As inspected 8th July 2021
CGH/8095**

BUILDING INSPECTION REPORT
OF
DONALD THOMAS CENTRE, CAMBORNE
WITH ADVICE FOR REPAIR AND MAINTENANCE

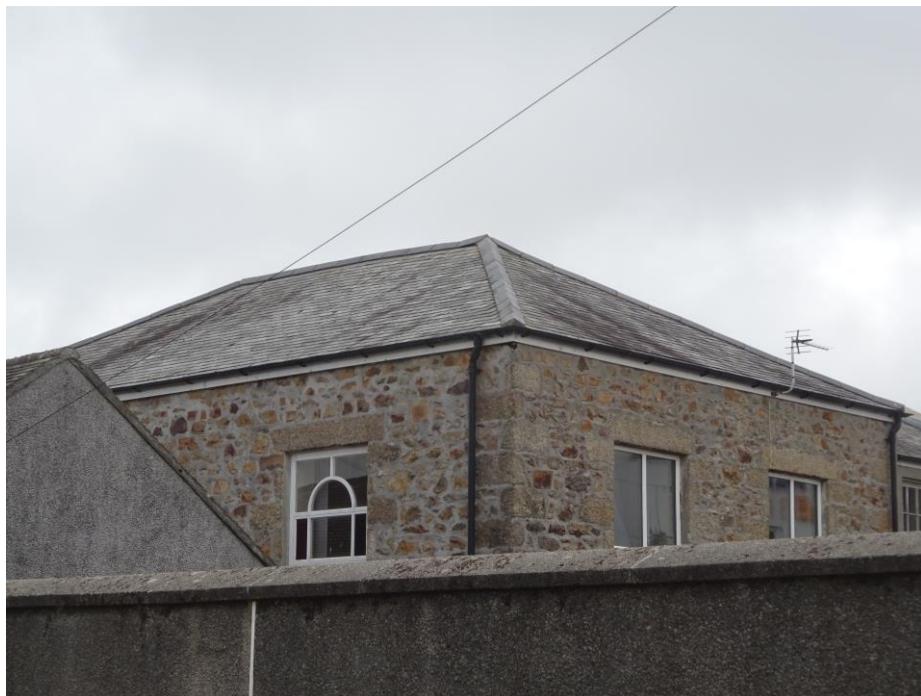
The roof is showing some signs of deflection and bowing, but this appears historic and there is no evidence of damage to walling below or the roof structure.

The slates are in generally good order. There are a few damaged / slipped / missing slates that will need to be attended to with replacements clipped into place. Cornish slates to match should be used.

1. View of R1 from west

There are a number of open joints to ridges and hips that need to be raked out fully and re-pointed in lime to avoid water penetration. The ridge tile to the far south side is sitting proud and would benefit from being re-set to reduce the bedding gap below and prevent water driving up underneath.

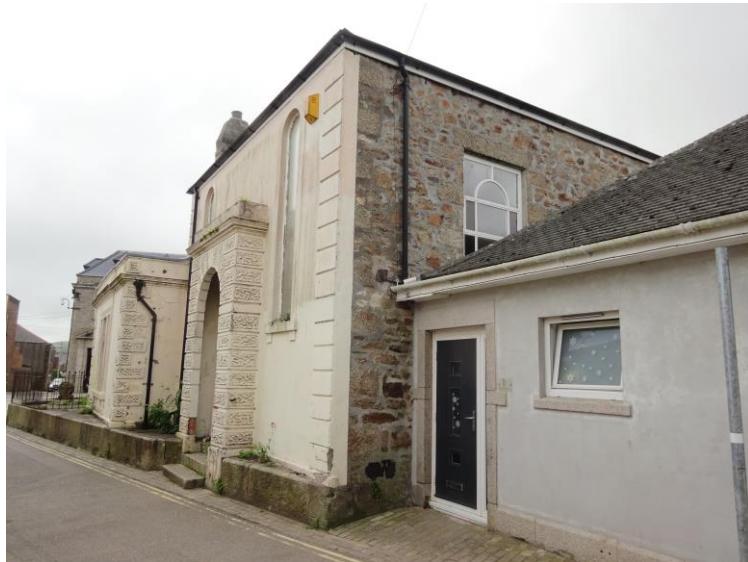
There is a simple square section timber fascia running around the roof. This appears in good order but would benefit from re-decoration.

2. View along north elevation with Wall 1 and R1 fascia.

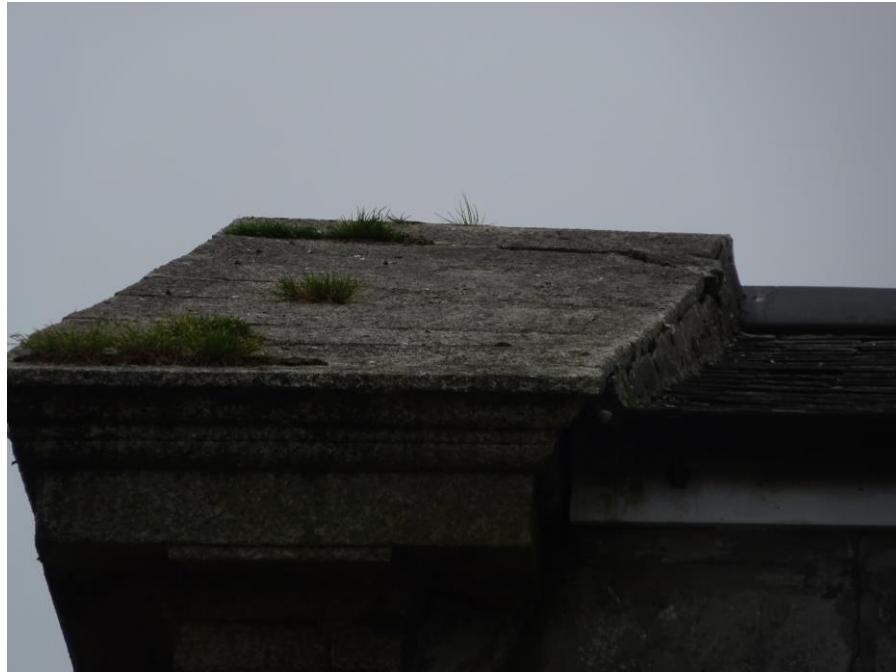
The roof to the east end runs to the coping to the pediment. On the north side this runs to a crude mortar fillet which is showing signs of cracking and deterioration. It is unclear if there is lead weathering under. This needs to be accessed, removed and more appropriate lead weathering provided to resist water ingress. There is evidence of water running down into the covered porch below in this location.

3. Coping on north side of R2

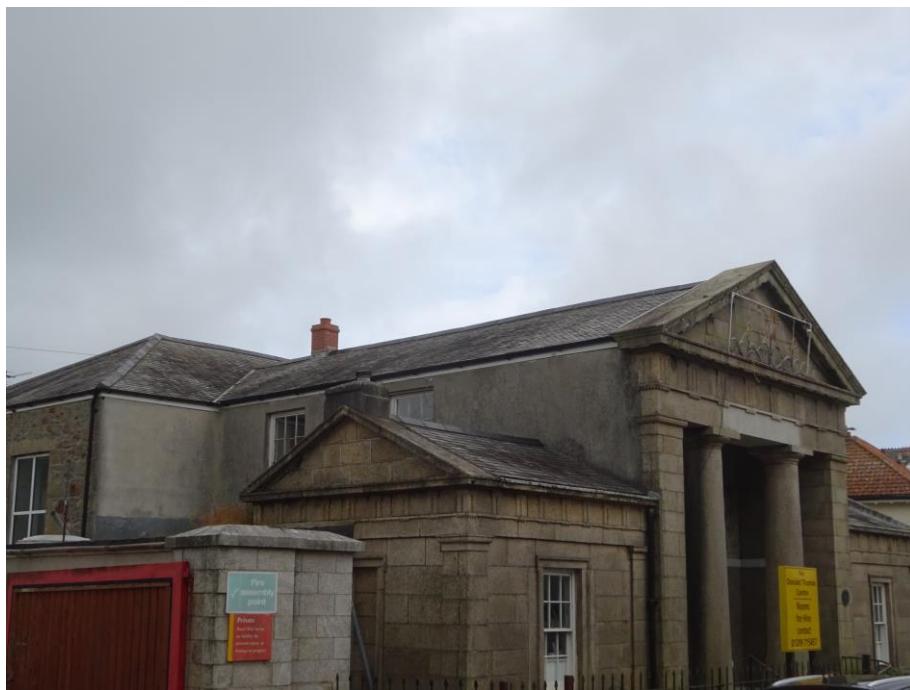
Roof is dry laid covered with natural Cornish slates with black clay angled ridge tiles. The slates are generally sound. Some slipped / damaged slates including a number to the pitched valley at the west end. These will require access and addressing accordingly.

On the south side a lead upstand has been provided with a small cover onto the coping. Due to the construction of the pediment coping it is not possible to provide a lead tray. Slightly more cover onto the coping would be beneficial to ensure the weathering here is sound. A similar detail would be required to the north side.

4. R2 from south side

Square fascia as above for R1. Re-decorate.

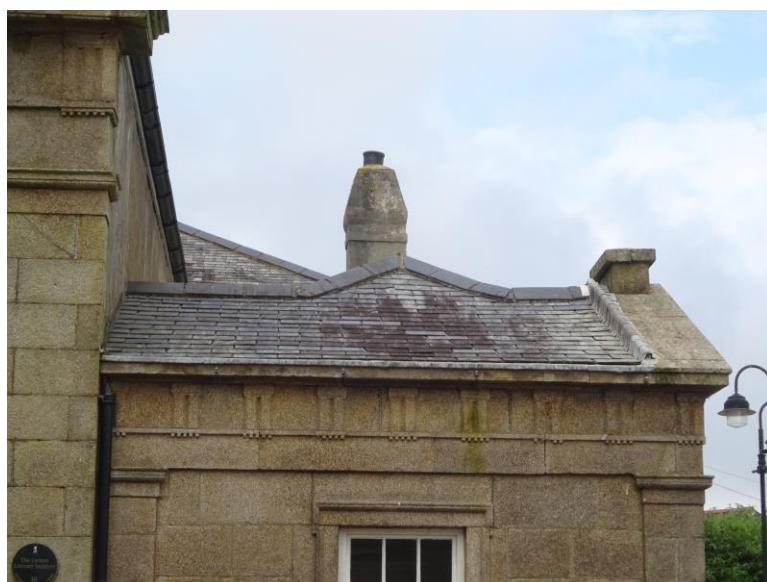
There is water ingress into the kitchen below from the roof above. Unclear what the cause of this leak is. There are a number of defects as outlined above.

The roof runs to a lead lined gutter on the east side, which is relatively shallow and runs to a tight outlet lead chute on the south side that runs into a downpipe. It should be investigated if widening of the outlet can be achieved to alleviate this potential pinch point for the water disposal.

5. R3 from east

R3 would benefit from being stripped and re-slated with improved lead weathering to the copings and re-bedding ridge tiles to ensure they are set correctly. Cornish slates should be re-used from the east side and matching slates brought in as required to other areas. Timber repairs may be required to the roof structure as there has inevitably been some deterioration due to the water ingress.

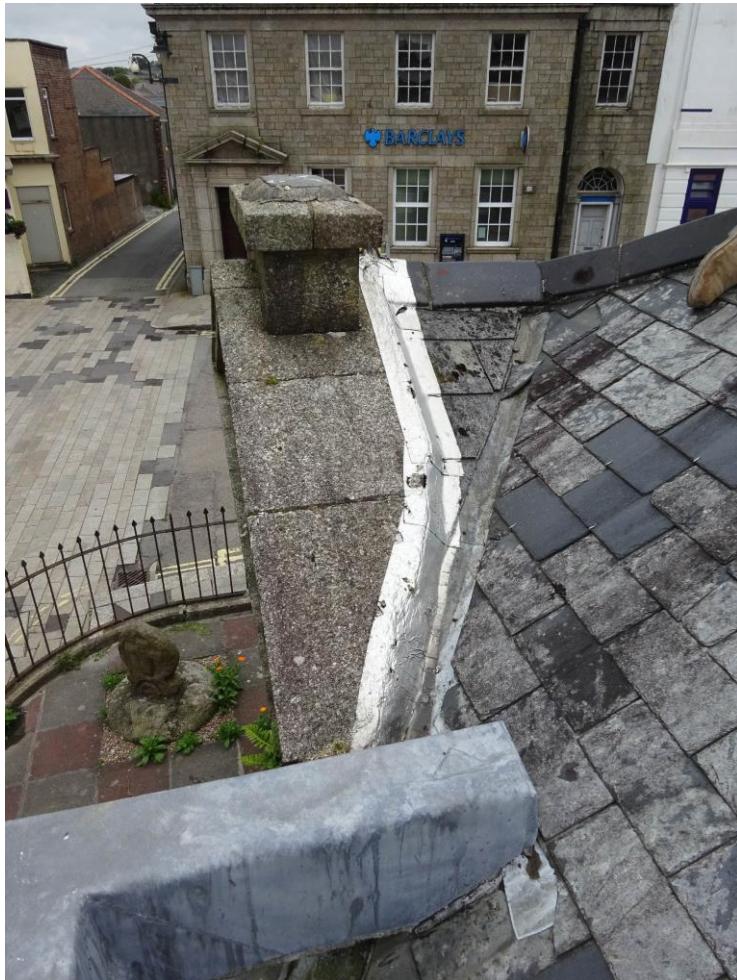
Flash band has been applied to the north gable on the west side which is a temporary patch repair system – there should be lead weathering detail to this point. On the east side a lead upstand is provided to the coping running over a raised roll to achieve height from the slate line. This is convoluted and unsightly – a secret gutter may well be an option to improve the detailing in this area.

6. Flash band to R3 west side

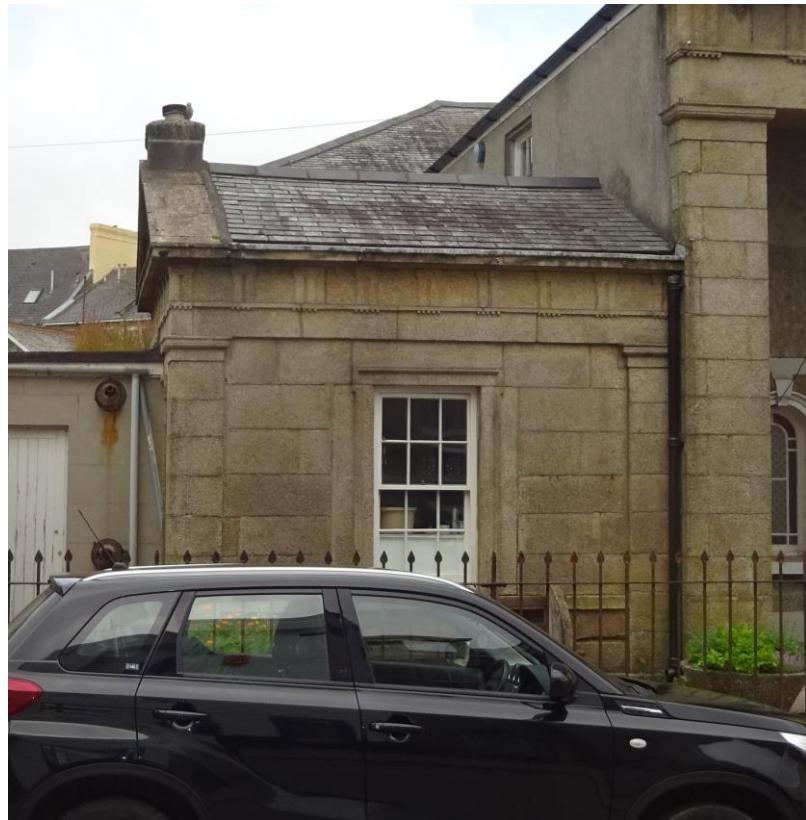
Small gable roof running to granite pediment. Cornish slates dry laid with black clay ridges. Generally the slates are sound with a small number of damaged slates near the wall abutment. Joints to ridges should be raked out and re-pointed.

There is no lead to the upstand of the copings. A mortar fillet weathers the abutment. This is cracking and will be allowing moisture to track down beyond the slate line, subject to the presence of any lead in this area. This needs to be addressed and improved and the option for a secret gutter in this location should be investigated.

7. R4 east side

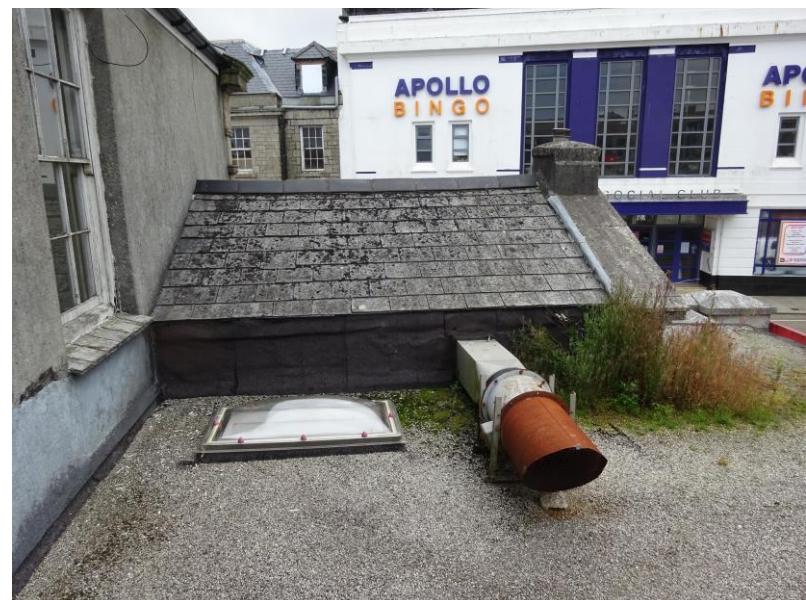
There is no lead evident on the north side against the building. Soakers and cover flashings should be provided to weather the interface between wall and roof subject to wider works on the rendered surface.

8. R4 west side

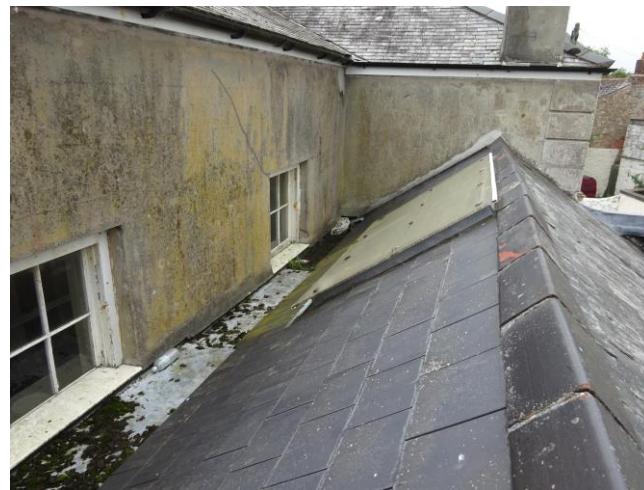
Part hipped roof over north infill. The north slope is natural slate as elsewhere. Generally sound although a number of slates have been repaired with clipped slates to repair. South slope is man made fibre cement slates clipped. This slate type is inappropriate for a grade II* listed building and has been provided in this area due to being hidden from view. Generally sound however. Slipped and damaged slates should be attended to.

The south slope runs to a lead valley gutter with three bays against north wall of eastern hall. On the north side the roof runs to a parapet valley gutter. A pitched valley runs between R5 and R3.

9. R5 south side

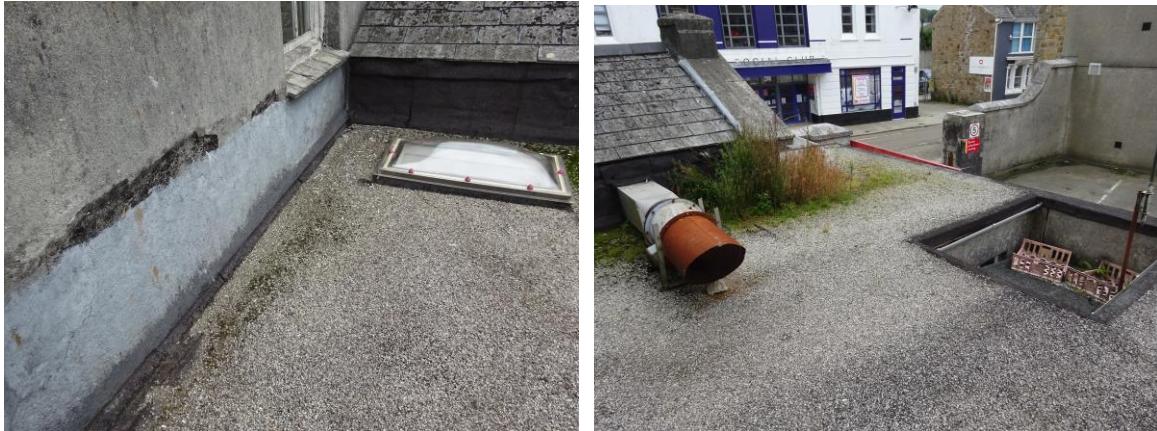
Built up felt roof. In poor condition with extensive areas of vegetation and ponding. There is water penetration to the skylights and the weathering details to abutments has been crudely done with upstands of felt and bitumen applied (see walling section below).

The roof feels relatively stable underfoot, but inevitably some damage will have been caused to the supporting timberwork given the amount of moisture that has tracked into the spaces below.

The soil and vent pipes from the lavatories run out at an angle over the flat roof, which is unsightly.

11. Flat roof to south side

The whole area is to be re-developed pending funds and permissions. If retained we would recommend completely re-laying the flat roof and providing lead detailing to the perimeter allowing at least 150mm upstand with cover flashing.

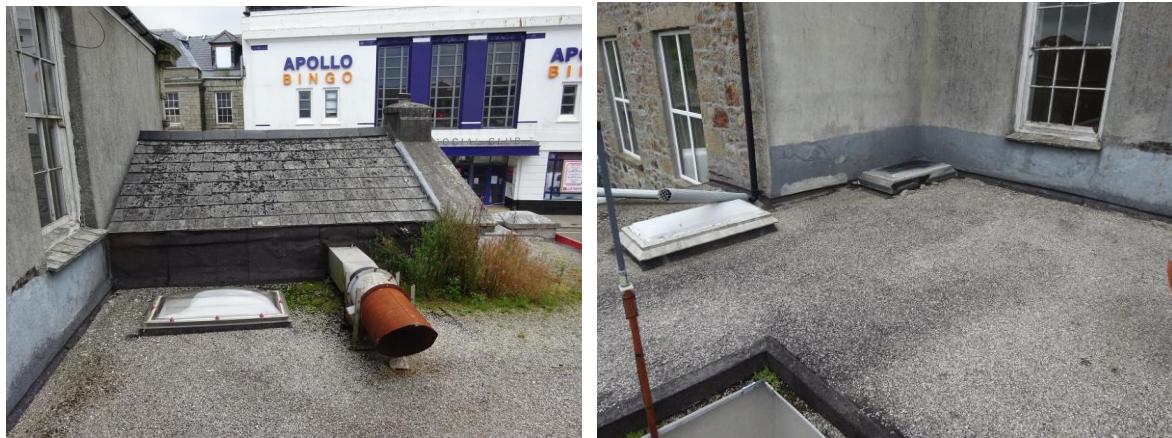
UPVC domed skylights to flat roof section – 3no. These are poorly detailed and deteriorating. There is extensive water penetration around the skylights. This whole area is scheduled to be re-developed. If retained for any length of time the skylights need to be completely overhauled with weathering improved.

12. Dome skylights to flat roof

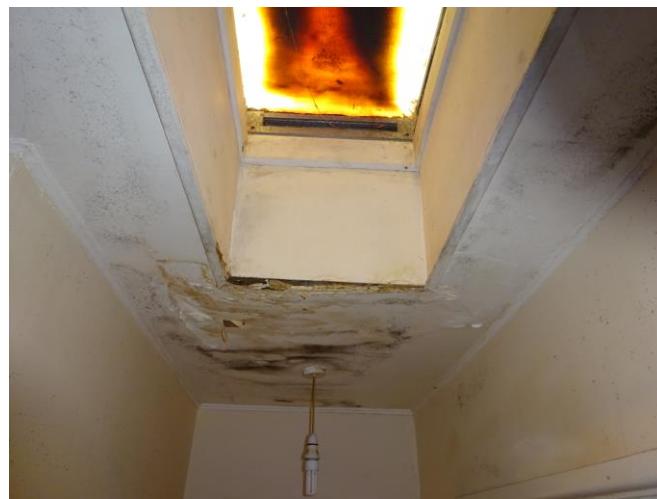
13. Internal water ingress from flat roof skylights.

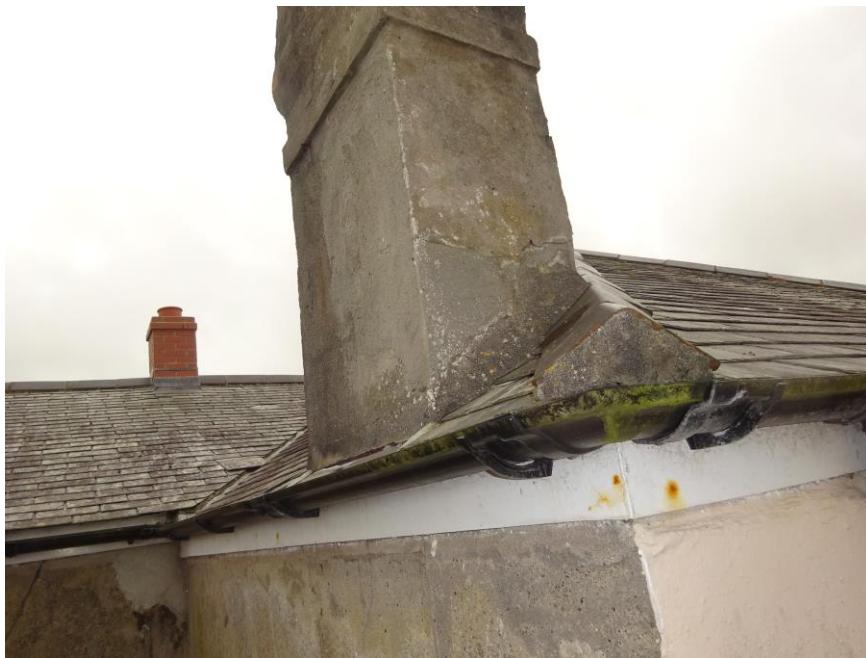
The chimney is leaning to the west and the render is loose and failing in a number areas.

Clearly there was some failure of the original structure and the cement render was applied as a way of addressing this. Unfortunately the impermeable covering has likely exacerbated the problem and cracking and displacement caused by movement and settlement will have resulted in water penetration and likely further accelerated deterioration of the brickwork behind.

14. Chimney C1

It is recommended that the chimney is accessed and taken down and then rebuilt in brick with an appropriate lead tray and detailing to the roof.

Hopefully the original profile of the chimney is visible beneath the render so this can be replicated when re-built.

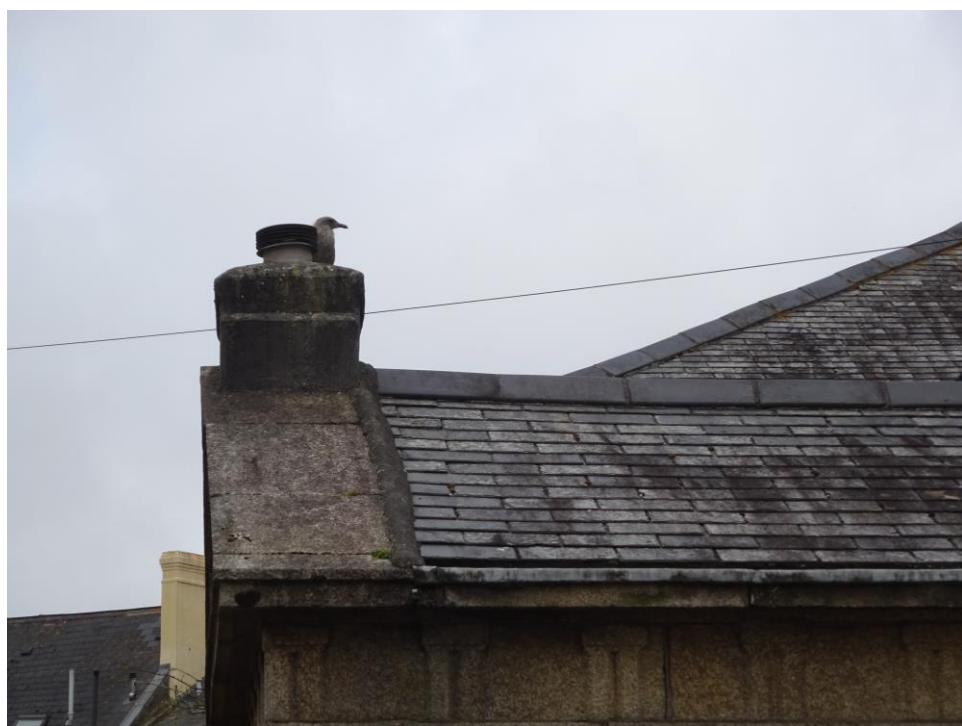
Stone chimney as per C3 rendered in cement. There is no visible lead weathering to the base. The rendered surface is unsightly and cracking will allow water to penetrate and be trapped in behind allowing for ingress internally and wetting of the masonry to the chimney and wall below.

15. Chimney C4

It would be beneficial to remove the rendering and allow for exposing the stonework. A degree of stone repair and weathering is likely along with some replacement.

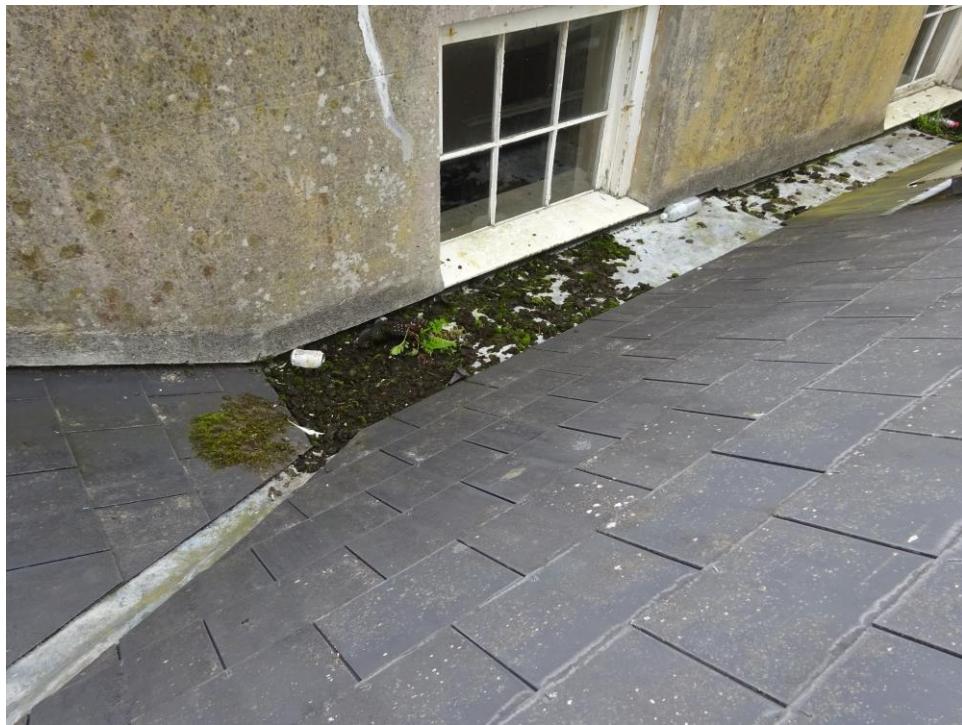
Lead valley between R5 and eastern hall wall. Three bays running to internal downpipe on west side. There is very limited upstand to the windows W15 / W16 and UPVC sections have been added to the cill to build up the levels. There does not appear to be a lead upstand, which is worrying. Unfortunately given the levels the window would need to be significantly altered to accommodate an upstand. There is evidence of rot to the cills to W15 and W16 under the UPVC panels indicating that some revision to the detailing here is required to provide appropriate weathering.

16. Lead valley to R5 south side.

The lead valley has debris and detritus that needs to be cleared to ensure weathering to the roof and abutments is not compromised. Regular access to clear and maintained will need to be undertaken.

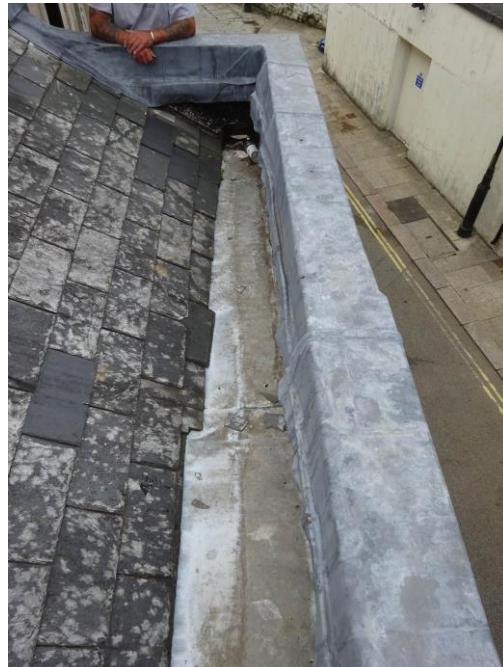
R5 north side runs to lead lined parapet. The lead is detailed well and sound. The capping to the parapet needs to be re-dressed in places to ensure capping lead is tightly secured to joints.

17. Parapet leadwork north of R5

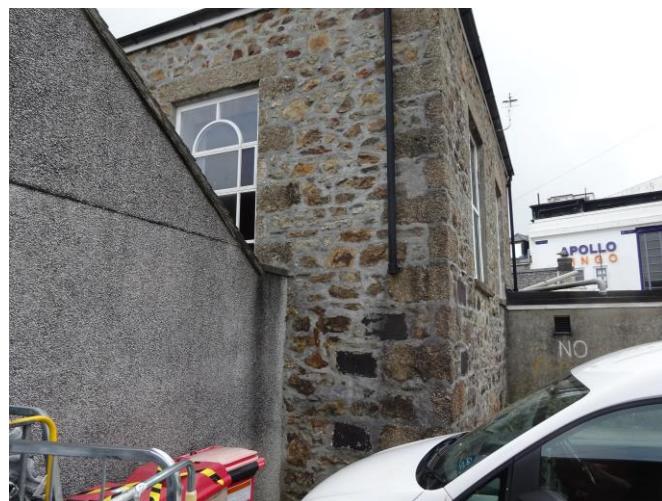
Downpipes are round pipes of the same. There is a missing section on the southwest corner into the Royal Mail car park that needs to be re-fixed.

18. Missing downpipe sections southwest corner.

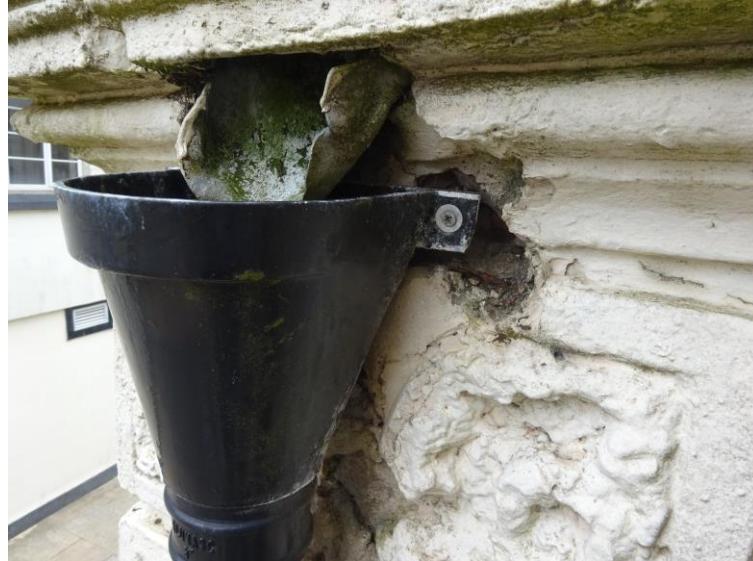
To the west end of the parapet gutter to north of R5 there is an aluminium hopper that has been crudely fixing into the walling with extensive damage caused to the rendering. The fixing hole is open allowing water to penetrate into the building – there is evidence of dampness below this point. The hopper and downpipe here needs to be re-fixed appropriately with improved discharge from the end of the lead gutter.

19. Hopper to west end of R5

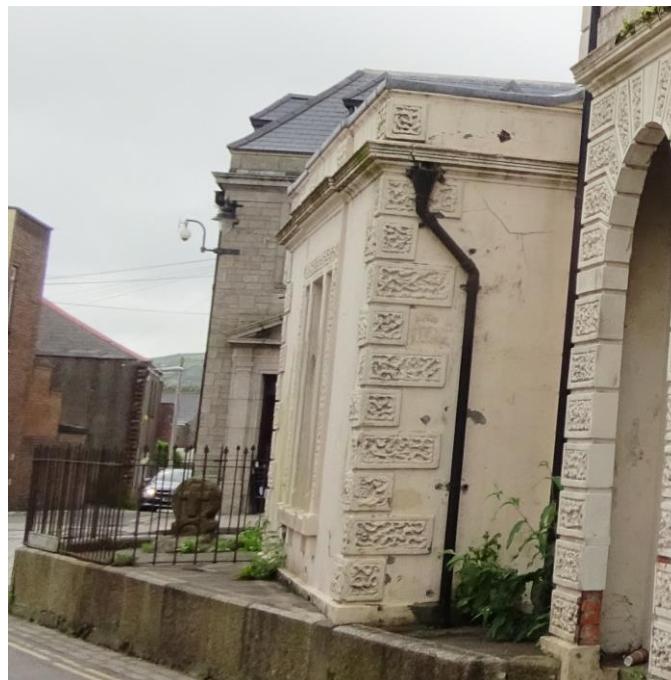
20. DP below hopper as per picture 19.

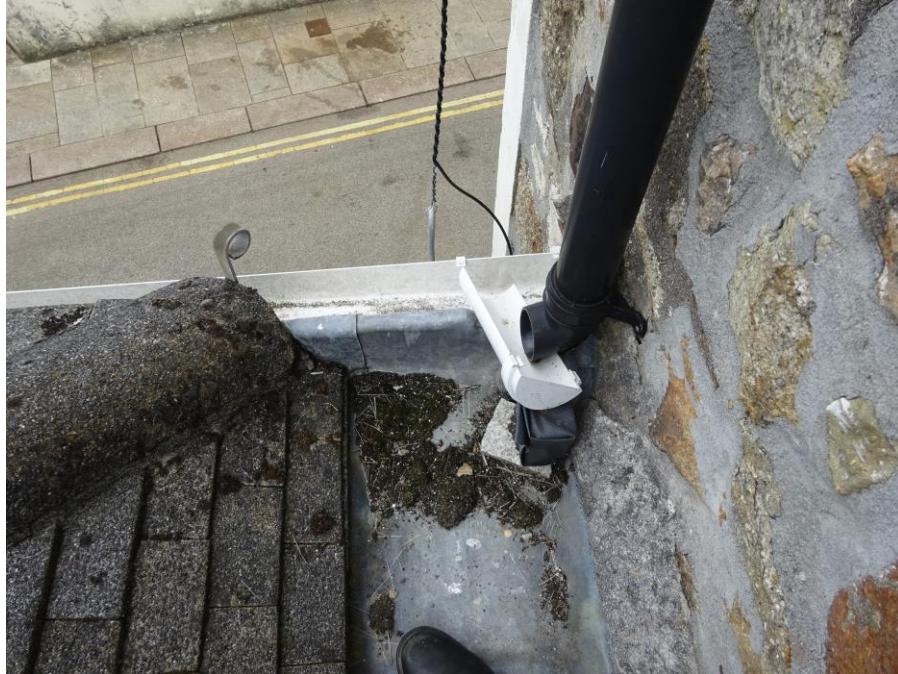
To the north side of the west lead gutter onto the old public conveniences the discharge is poorly detailed with a small section of UPVC pipe running from the swan neck to the front gutter of the neighbouring property. Relocating this downpipe outside of the line of the lead gutter to discharge to the street would be beneficial and avoid water build up in this pinch point. This was likely adapted when the conversion works to the public lavatories took place.

21. Poor downpipe outlet detail to northwest corner of western hall.

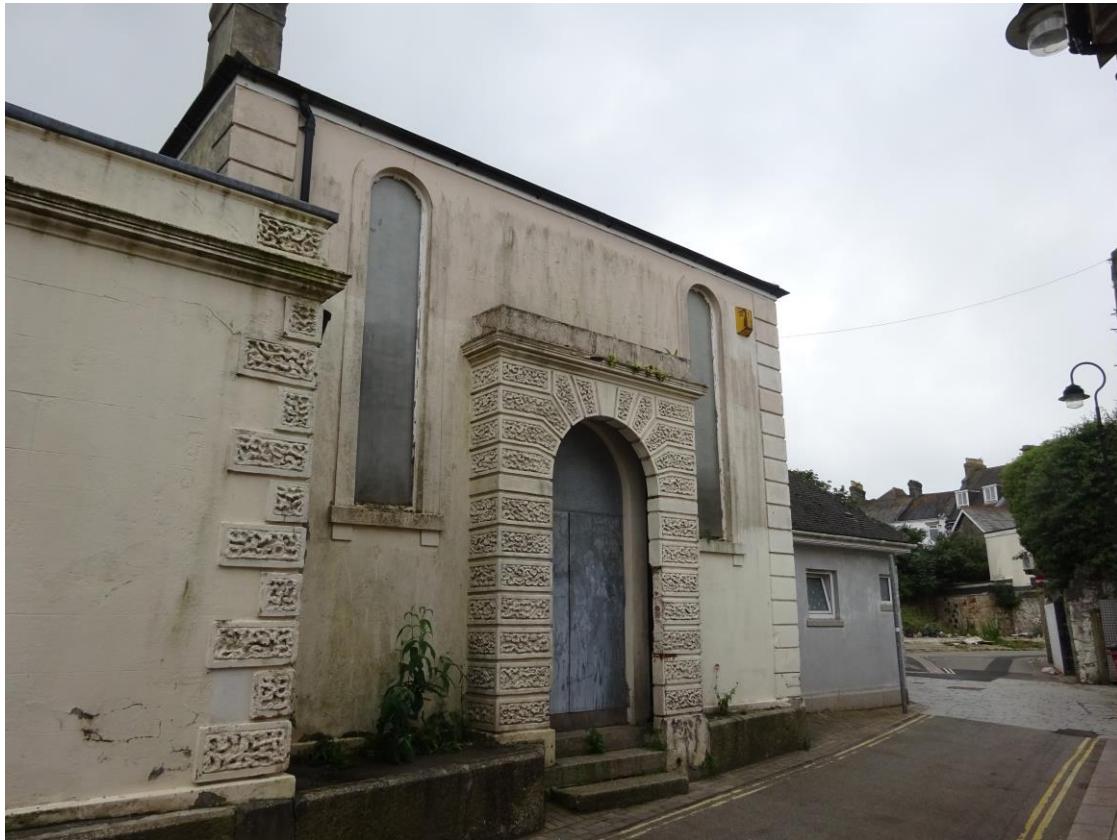
There is cracking evident to the stucco particularly to the corners and edges and vegetation has taken hold in a number of areas. There is evidence internally of water penetration behind the stucco sections and clearly moisture is being trapped behind.

Within the portico are original fixing points from an outer gate. These are rusted and have cracked the rendering and damaged the brickwork behind. These need to be removed carefully and the masonry repaired accordingly.

22. North wall of western hall.

It is recommended that the stucco is carefully removed to access the masonry behind to the main wall and the portico. Repairs will be needed to the masonry as necessary. A lime based stucco should then be applied using the same detailing. This should be a 'common stucco' formed from hydraulic lime, sand and hair. This will be a fully breathable surface allowing moisture to evaporate through the walling externally.

The original detailing should be retained, and the walls should be painted in a breathable mineral based paint.

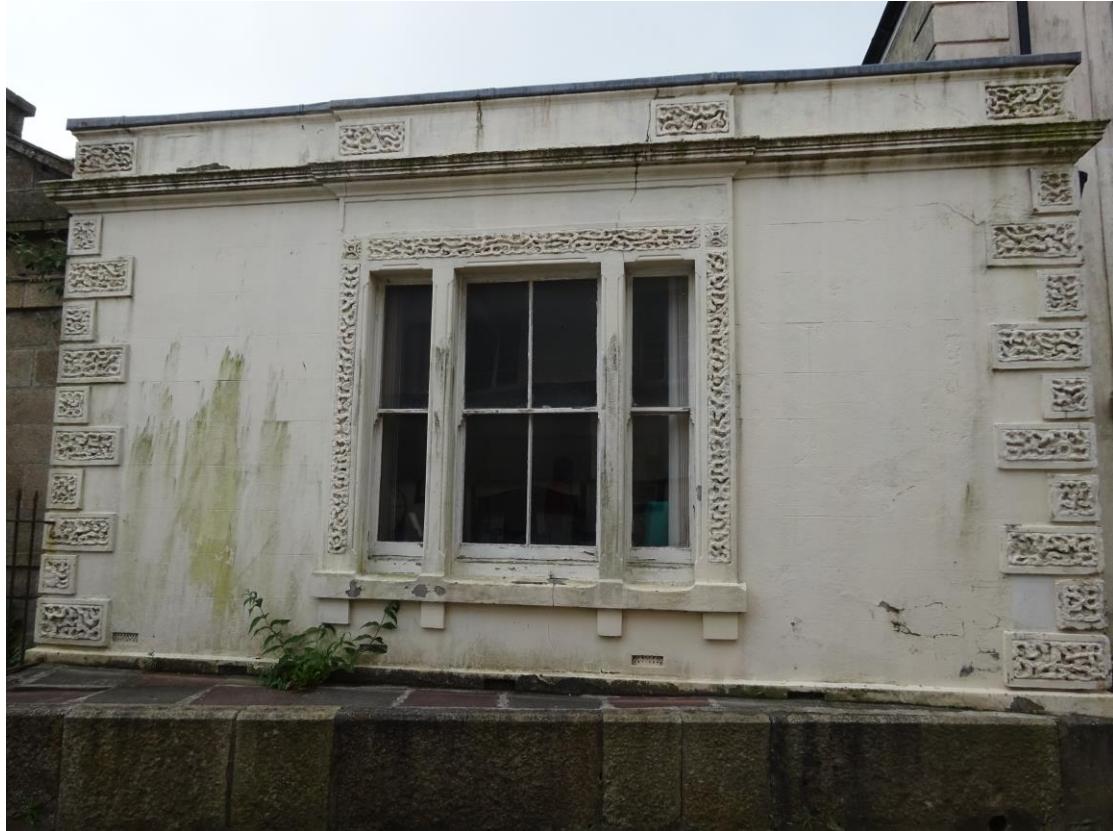
The stucco is cracking in areas and the paint surface is deteriorating. There are open joints and holes particularly behind the downpipe on the west side of this section. The render is hollow when tapped indicating that it has lost adhesion. As above it appears to be a cement based stucco.

The detailing to the base of the wall is poor with a number of open joints and cracks. The cracking and joints will be allowing water to penetrate in behind the render and lead to water penetration into the core and into the building.

23. Wall 3.

It is likely that repairs to the masonry is required below the render and this should be attended to once the wall surface can be assessed.

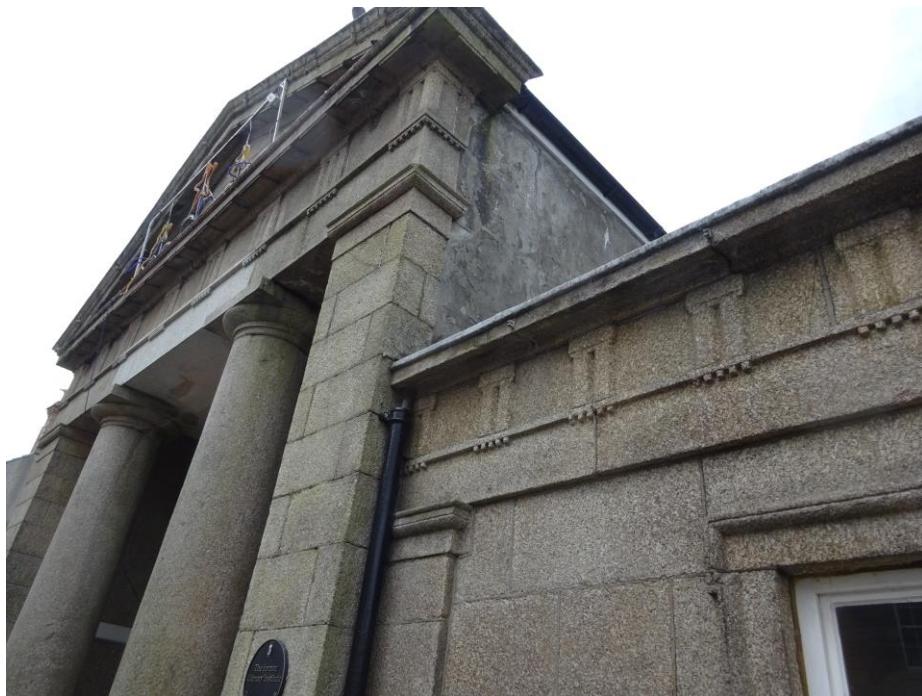
24. View up towards frieze and pediment.

It was not possible to check the flat section of the frieze, but the area is used extensively by pigeons and a build up of debris and detritus plus a lack of flaunching and open joints to the detailing will allow water to penetrate the wall sections. The pigeon spikes are not functioning properly and steps are in place to renew these.

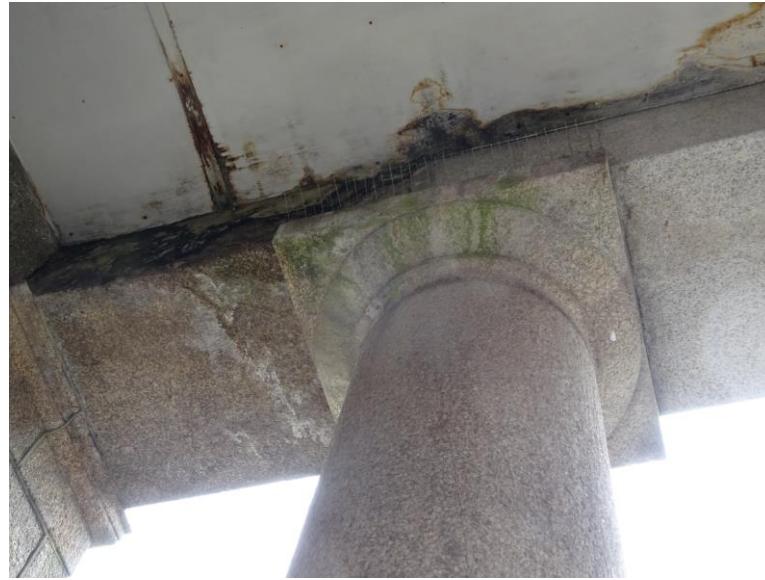
There are large section granite lintels over the columns. The central lintel has been replaced as the stone is much newer and less pollution stained. The side stones are original and showing some signs of delamination, which is likely what occurred to the central lintel.

A close investigation is required but from below the granite looks stable although minor cracking needs to be investigated. Clearly there has been water ingress that has caused this as a result of the abutment detailing to the roof above, the open joints and potentially penetration to the flat section above the frieze.

25. Delaminating lintel over column.

The frontage needs to be raked out and repointed in hydraulic lime mortar with a fine sand as per general comments below. The area above the frieze needs to be accessed and potentially flaunching or clad in lead to allow water to run off and away from the building. Granite should be cleaned down to remove green staining / growth.

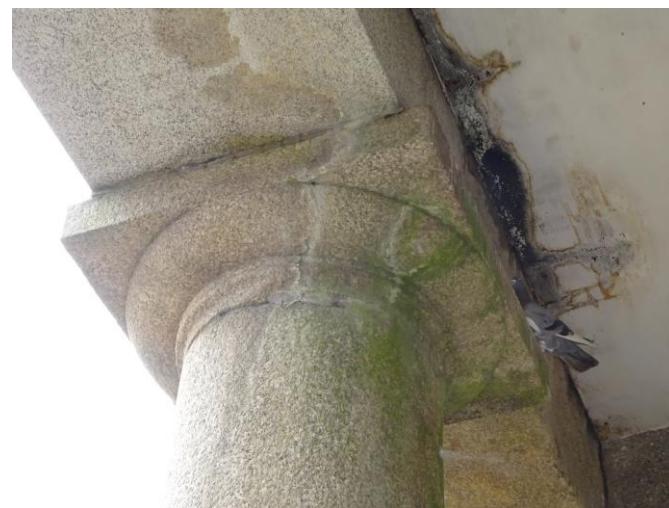
Inside the outer porch there is what appears to be a hardboard ceiling. This has been heavily affected by water penetration from the east and potentially roof above. There is rot and heavy mould staining. This should be removed and replaced with a stable external quality boarding such as Multiboard or Supalux. The boarding should be checked for asbestos. This is contingent on the pointing and detailing work as described above to the portico and pediment area generally.

26. South column and boarding.

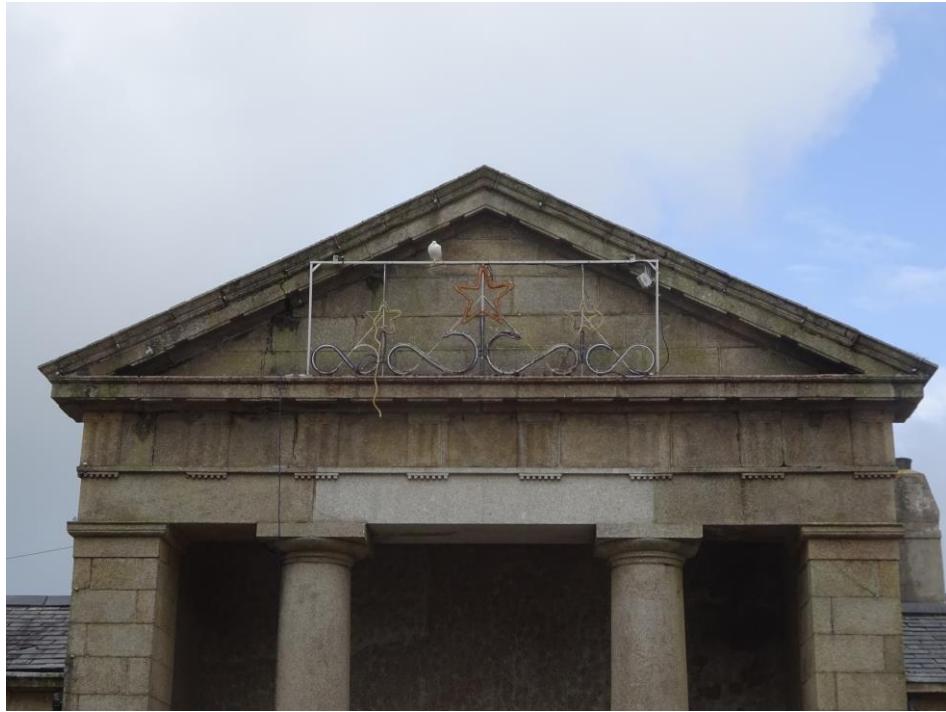
In addition, Christmas lights have been secured directly to the stone faces, which is inappropriate and has caused damage. The cable runs through the window frame of W7. Fixing into mortar joints is preferable. This can be addressed once full access to this area for re-pointing is undertaken as the lights will need to be removed to accommodate this.

27. View of pediment – note Christmas lights.

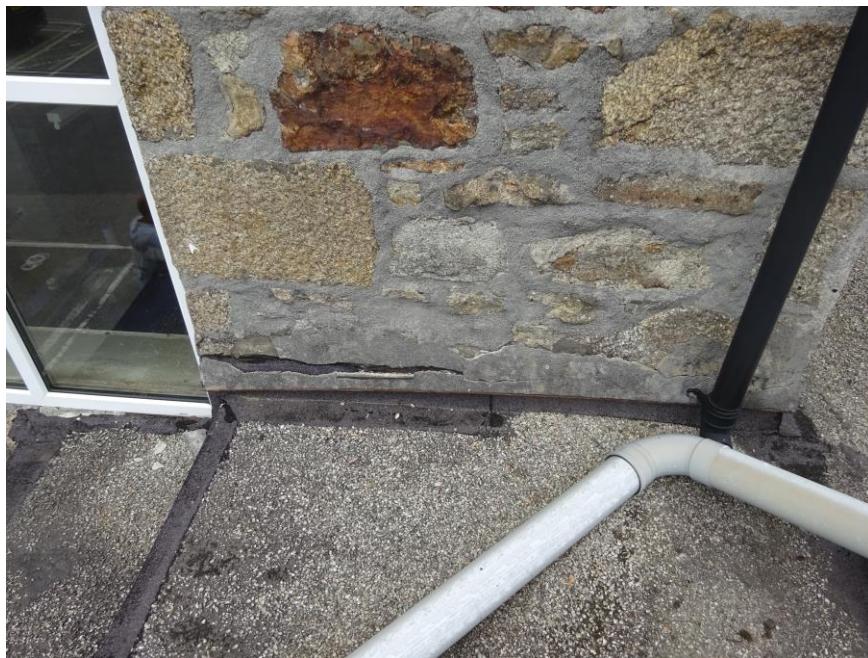
The upstand from the flat roof that cuts across this wall has been taken up in felt and provided with a mortar fillet. This has been very crudely done. The cement has failed and the upstand is both insufficient in height and poorly dressed. This has resulted in water penetration to the lavatory below and very likely damage to the flat roof timbers and penetration into the western hall east of window W5.

28. Defective weathering from flat roof to Wall 8.

The upstand here needs to be attended to and a correct lead flashing applied – pending any development of the flat roof area.

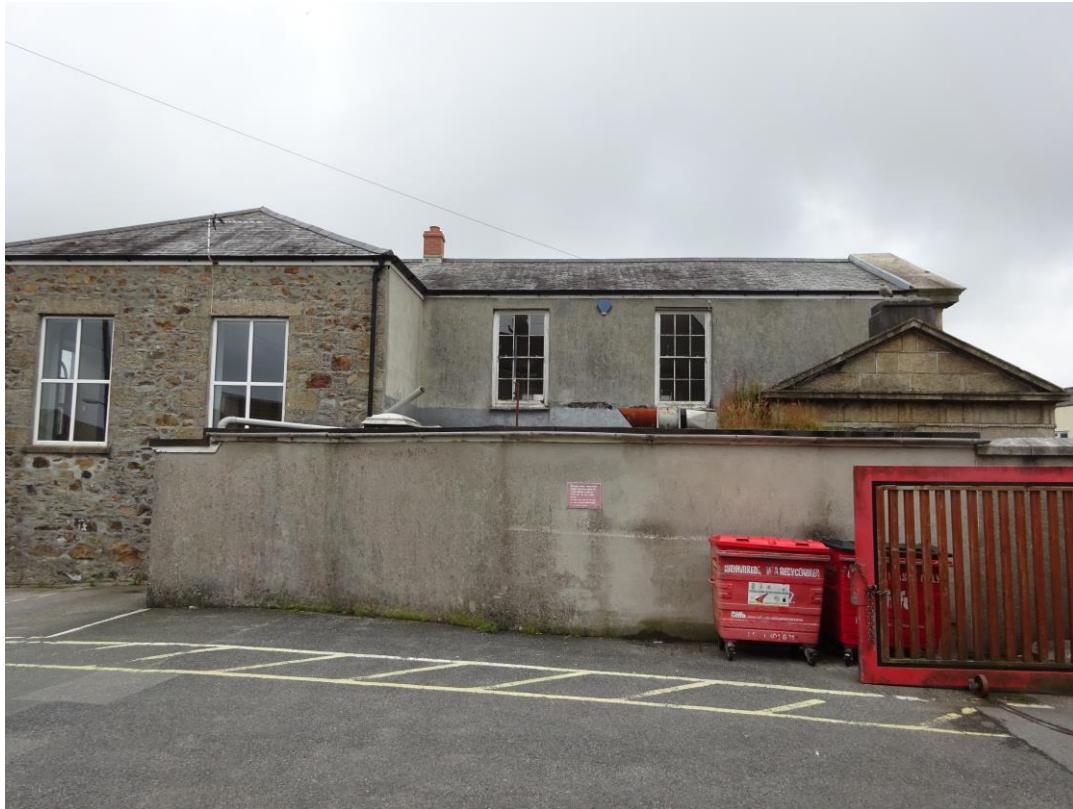
The walling here is assumed to be rubble stonework as per the western hall. It has been rendered with an inappropriate cement render system. This is cracked in multiple areas and will be allowing moisture to enter behind the render and become trapped further deteriorating the wall below.

There is evidence of water ingress all along this section of wall internally as a result of trapped moisture.

29. View of south elevation wall.

The application of a lime render will enable the wall to breathe effectively allowing trapped moisture to evaporate out.

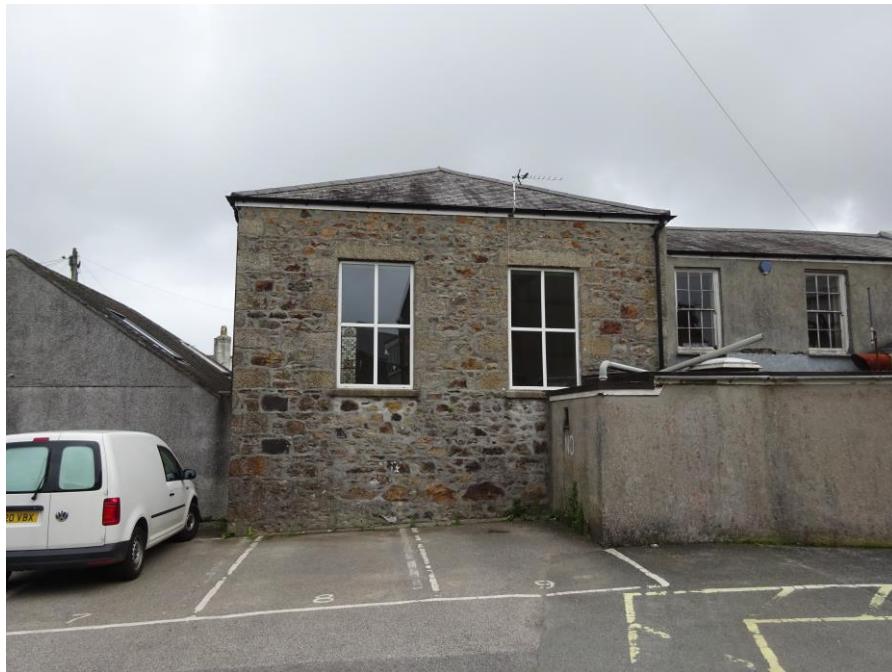
Unfortunately the south windows of the western hall have been replaced with UPVC. These are completely inappropriate for the listed building and should be removed and replaced with an appropriate timber window. The windows in themselves appear sound. They have been provided with mortar fillets to the reveals.

30. South side of western hall showing windows W4 and W5.

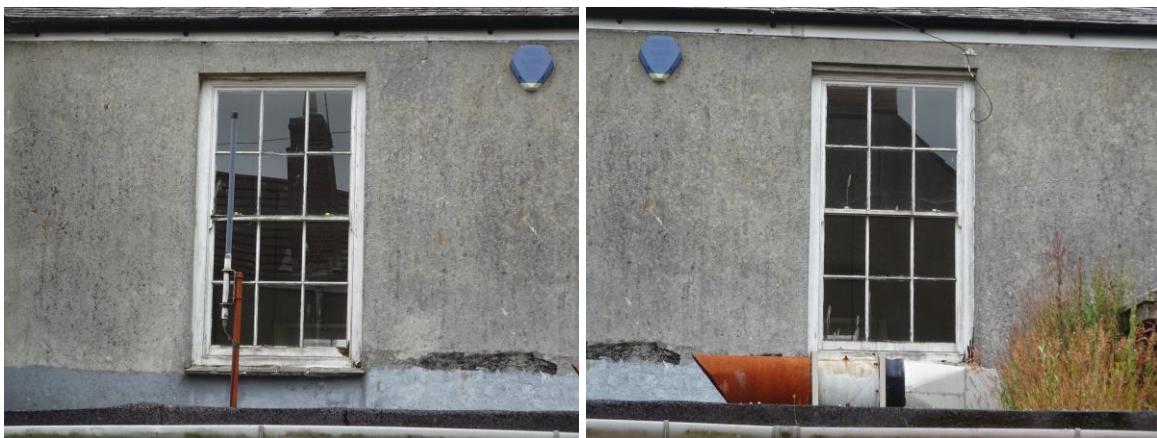
The windows have slate clad external cills. The slates are loose and require resetting.

31. Windows 13 and 14.

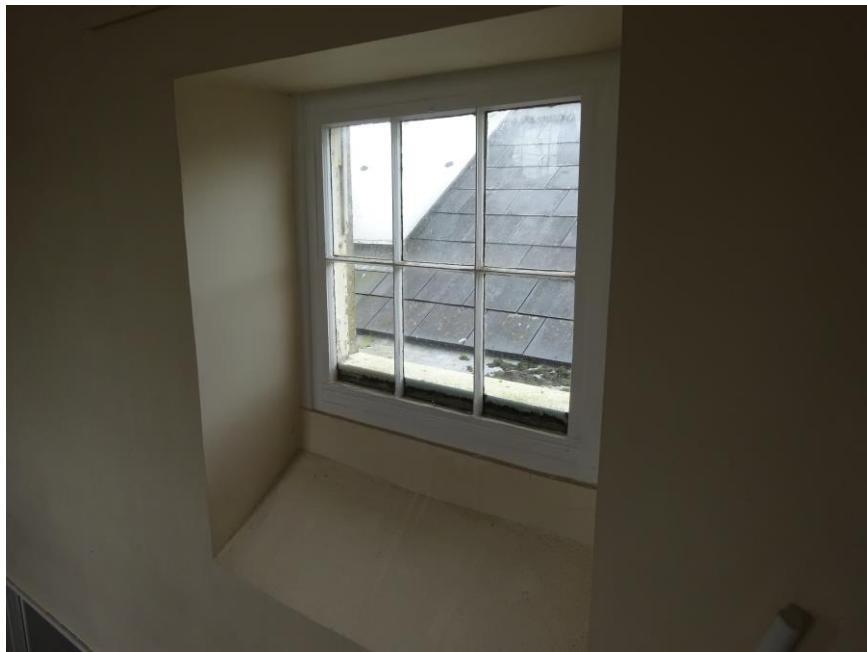
Fixed timber frame single glazed windows – appear to be previously top hung pivot windows. Externally the windows have been provided with UPVC panels to bring the upstand height over the lead valley up. There is evidence of rot under the UPVC. These windows need to be removed and potentially re-modelled to allow sufficient upstand externally. Re-putty and re-decorate.

32. Window W15.

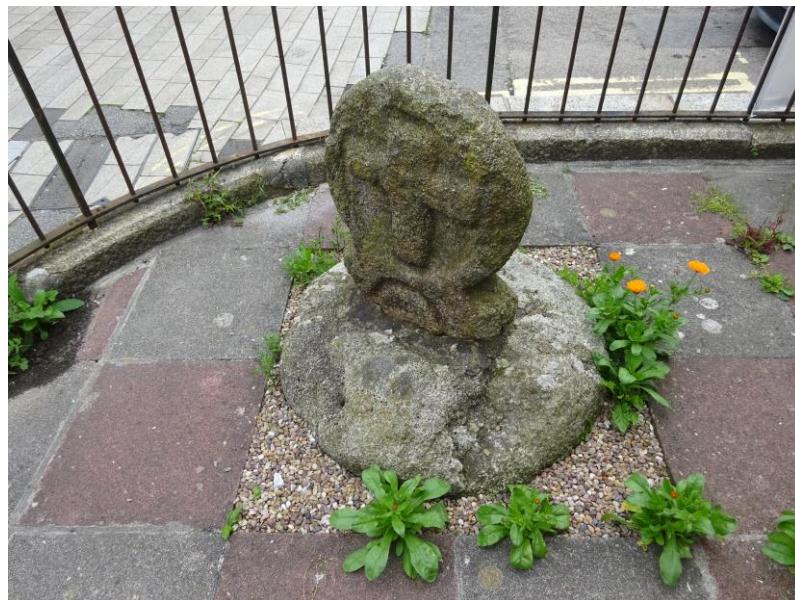
The granite wayside cross is located to the northeast corner of the courtyard. The upper shaft is all that remains of the original cross and it sits on part of another cross in a small gravel area. The upper shaft is cemented to the lower base and this has loosened over time with cracking and joints opening up. The cement should be raked out and repointed in lime. This will need Scheduled Monument Consent and close liaison with Historic England. The cross will need to be carefully protected when any works on the building takes place.

34. Wayside cross.
