**BUILDING INSPECTION REPORT
OF
DONALD THOMAS CENTRE, CAMBORNE**

**Scott and Company
3 Lemon Villas
Truro TR1 2NX**

**As inspected 8th July 2021
CGH/8095**

BUILDING INSPECTION REPORT
OF
DONALD THOMAS CENTRE, CAMBORNE
WITH ADVICE FOR REPAIR AND MAINTENANCE

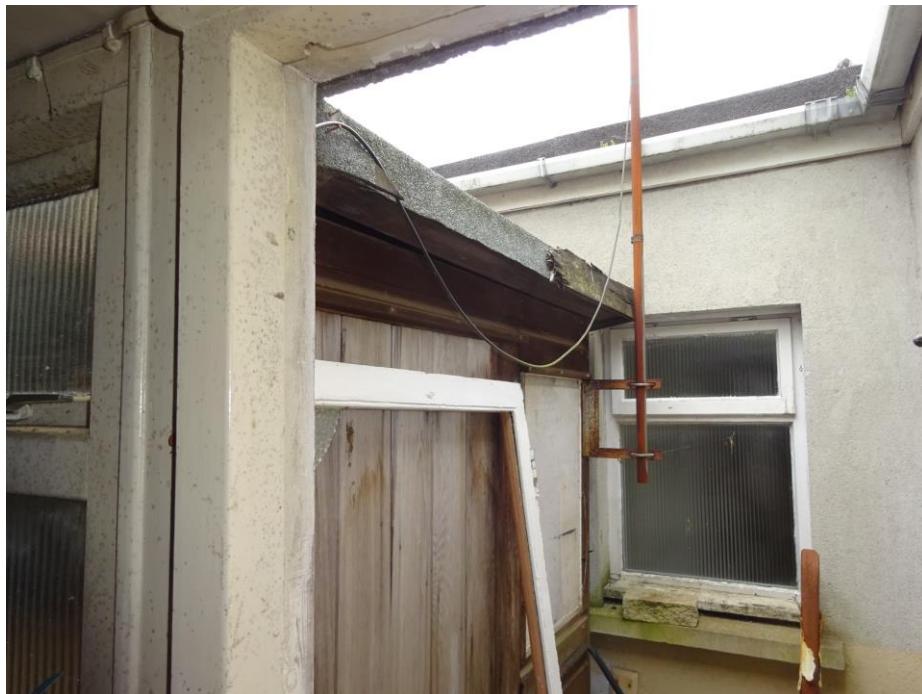
Small yard with dilapidated shed and inner guttering that does not drain effectively. This area is due to be developed. If retained for any length of time attending to the drainage of this area and potentially removing the shed to open up the area up.

35. Shed within inner yard (flat roof section).

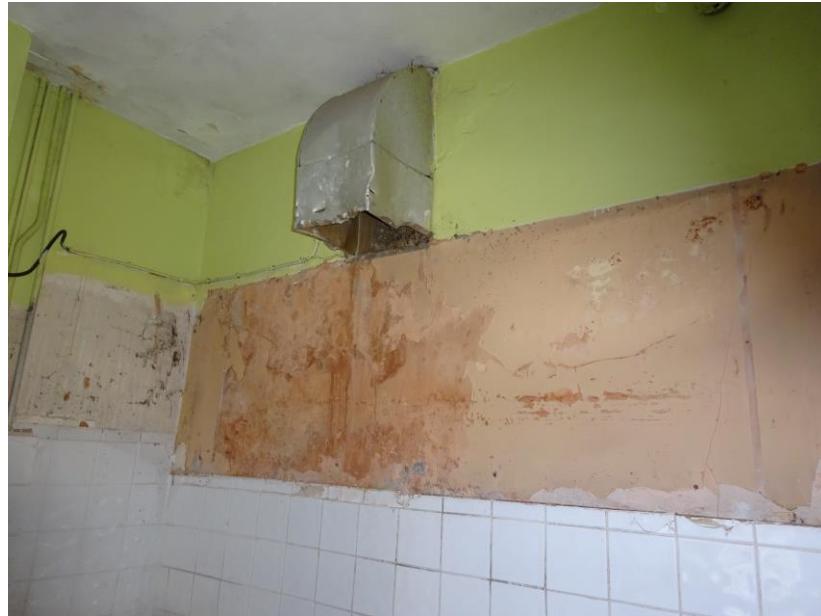
41. West wall of south kitchen.

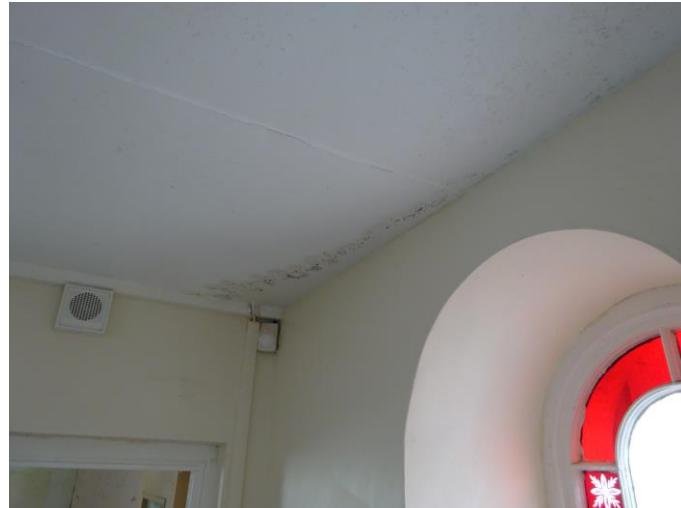
42. Damp stain to east corridor north side.

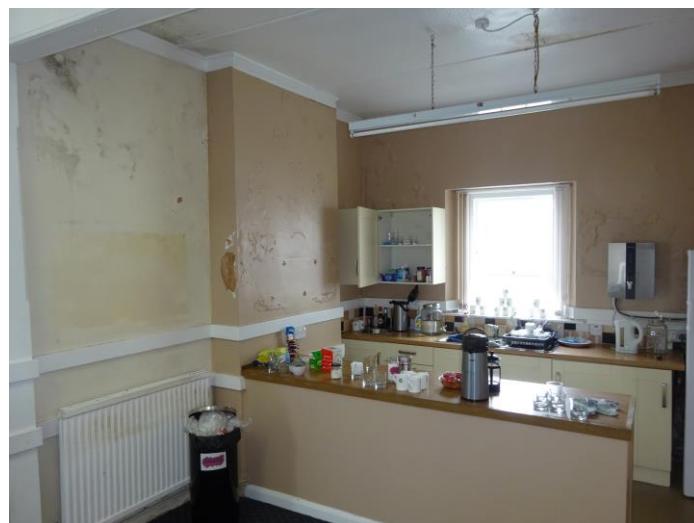
Plaster on solid painted. Plaster failure on north wall due to water penetration and damp penetrating from above (flash band applied to stop ingress) and through open joints. Strip and re-plaster north wall in lime.

43. North kitchen.

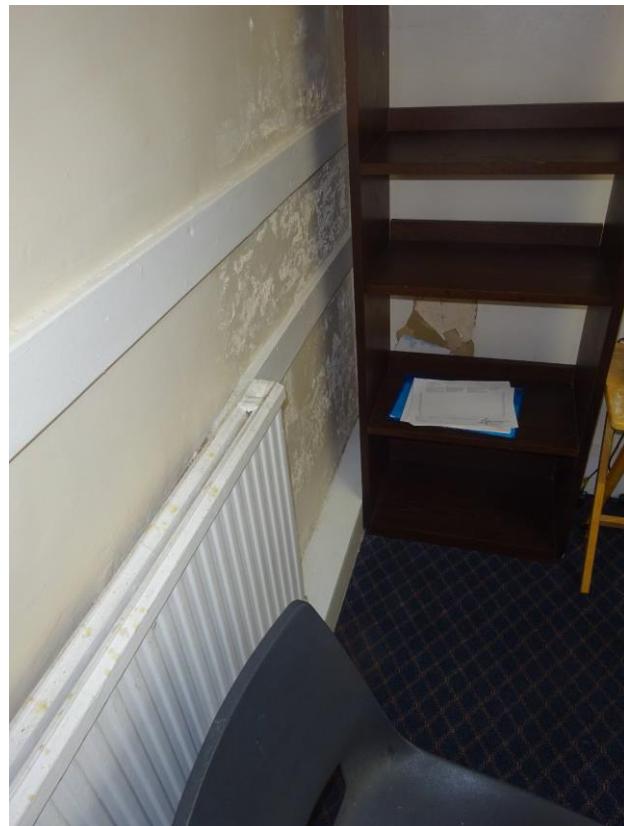
Plaster on solid. Small section of plasterboard to west of window W10. Damp staining below window and to west wall, which relates to the downpipe issues externally. Damage to plaster west of window. Condensation mould staining due to limited thickness of wall. Minor cracking throughout. Strip and re-plaster in lime. Subject to further investigation. Boxing to downpipe as described above.

44. Dampness to infill hall due to defects at downpipe.

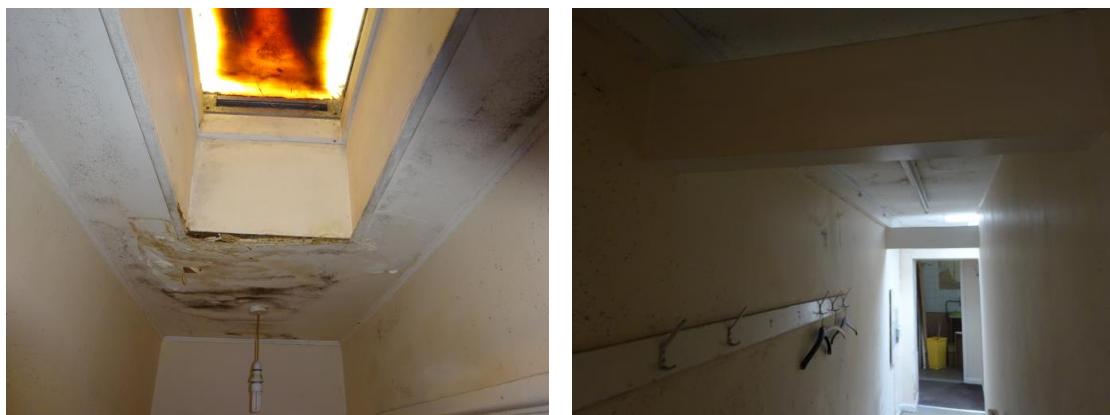
Tie lintels (3no) within corridor. Some deterioration to plasterboard boxing due to water ingress from above. Replace boxing as required if retained.

45. Views to corridor particularly ceiling defects.

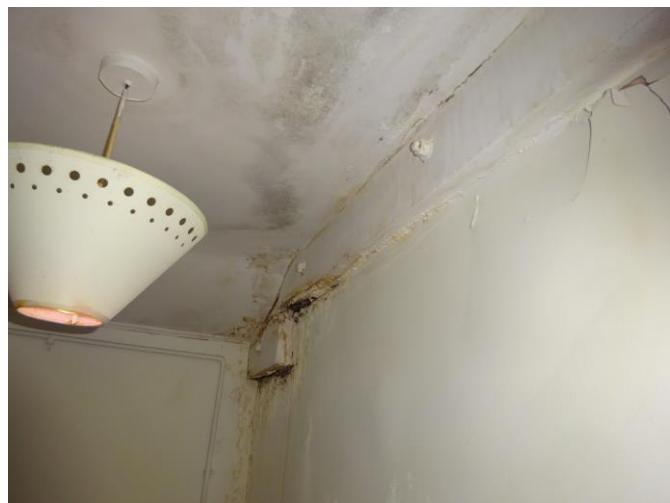
46. Damage to ceiling / wall accessible lavatory north side.
