## Refurbishment Survey

Survey Reference Number: L-23559

Donald Thomas Centre  
Camborne  
Cornwall  
TR15 2DB

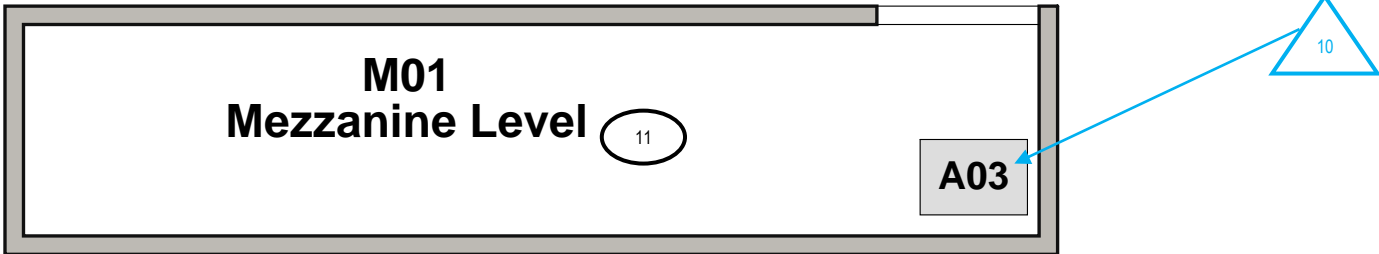
Please note: Where provided floor plans should be regarded as sketch-plans and for identification purposes only. They are intended to provide a visual appreciation of the buildings surveyed, showing locations of suspected ACMs, areas of no access and where samples were taken.
